Dipl.-Ing. Gregor Stolarski, Germany

Design baseline for reconstruction – archives deliver old materials

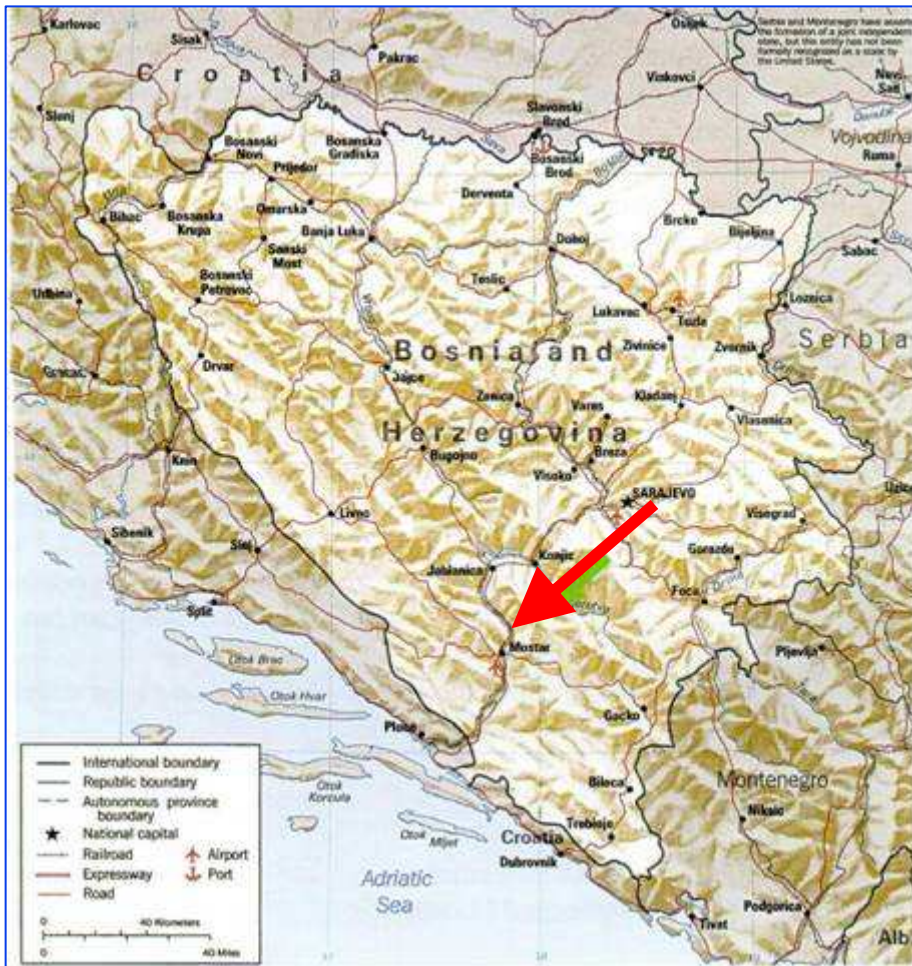
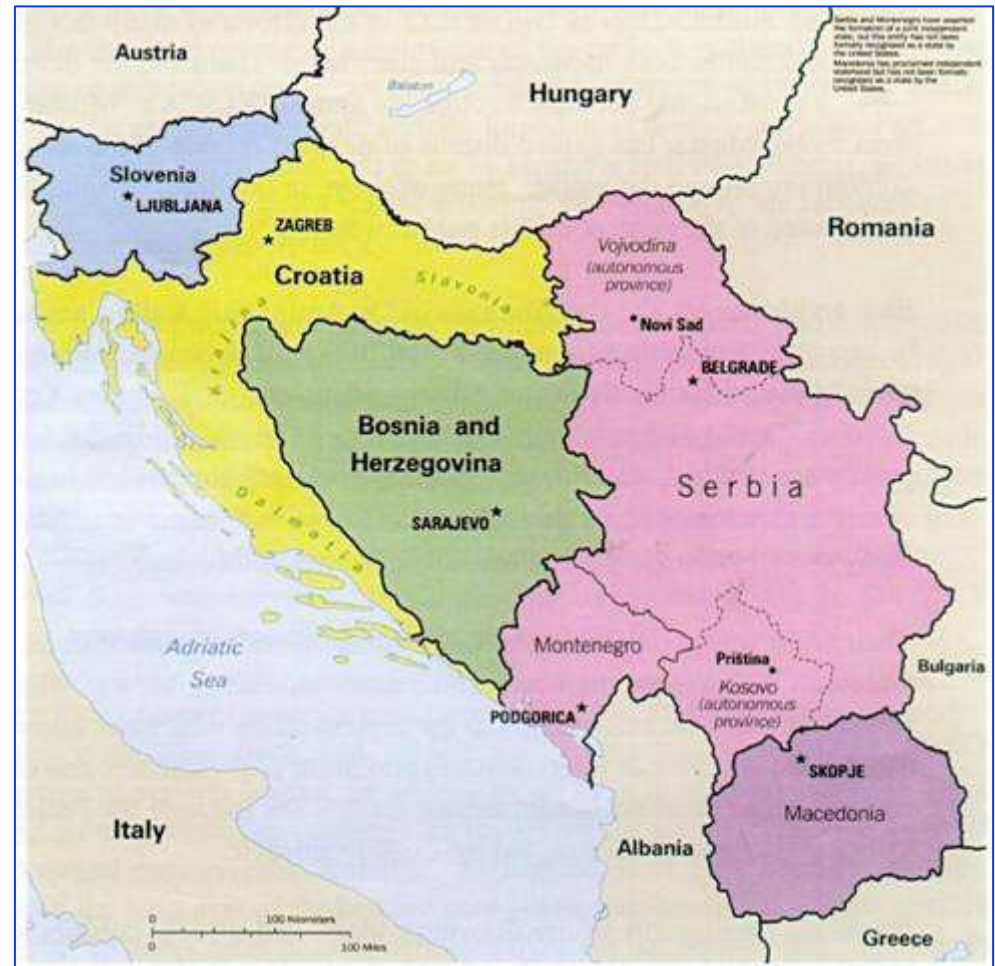
Ground conditions are difficult, strong erosion, brittle rock

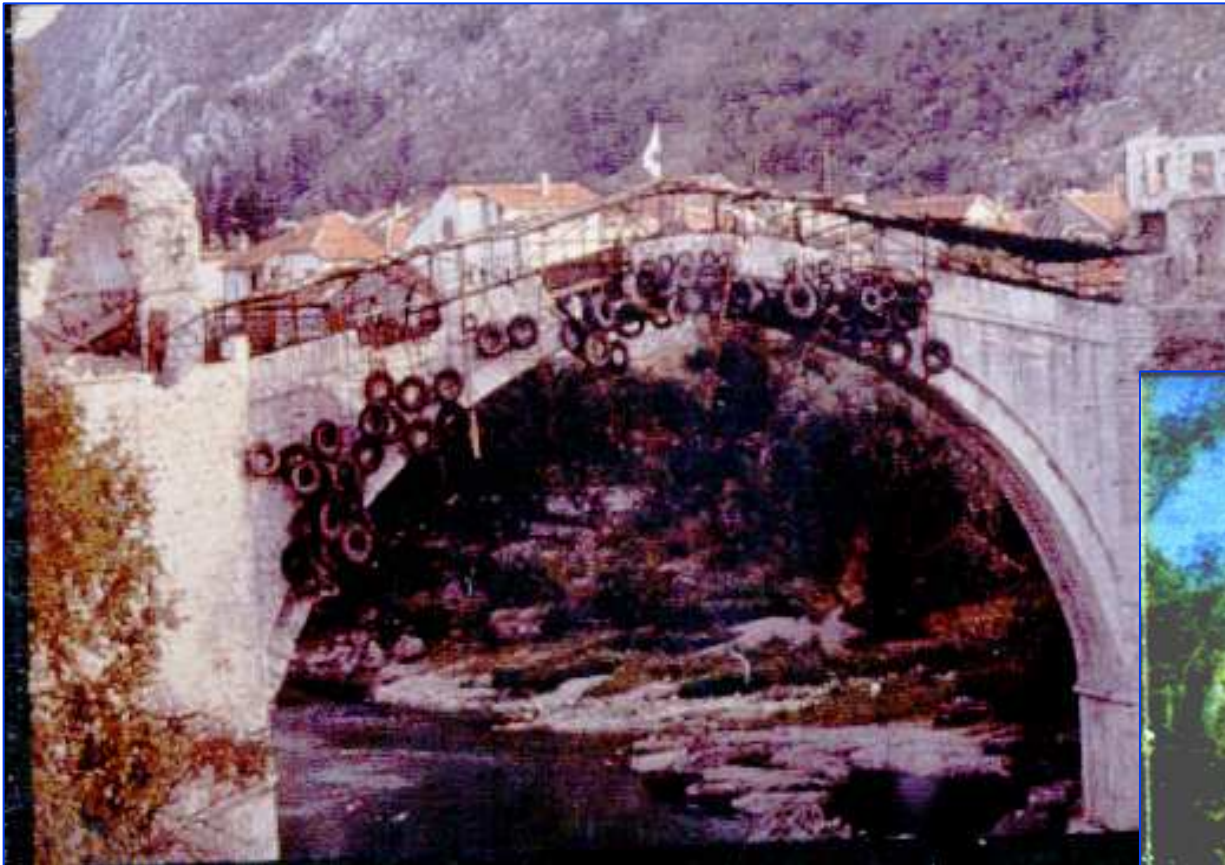
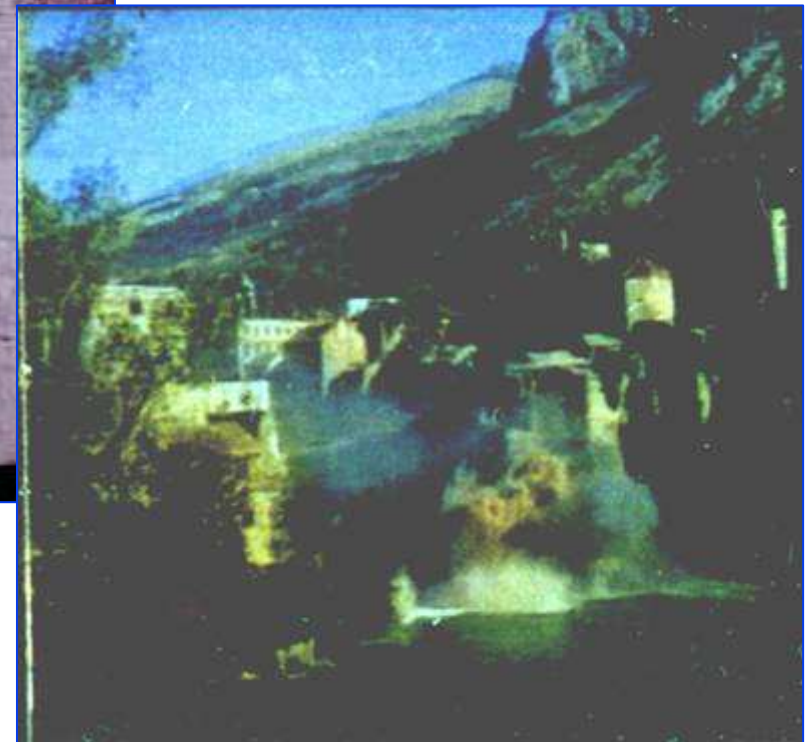
The ruins after the collapse – details of construction

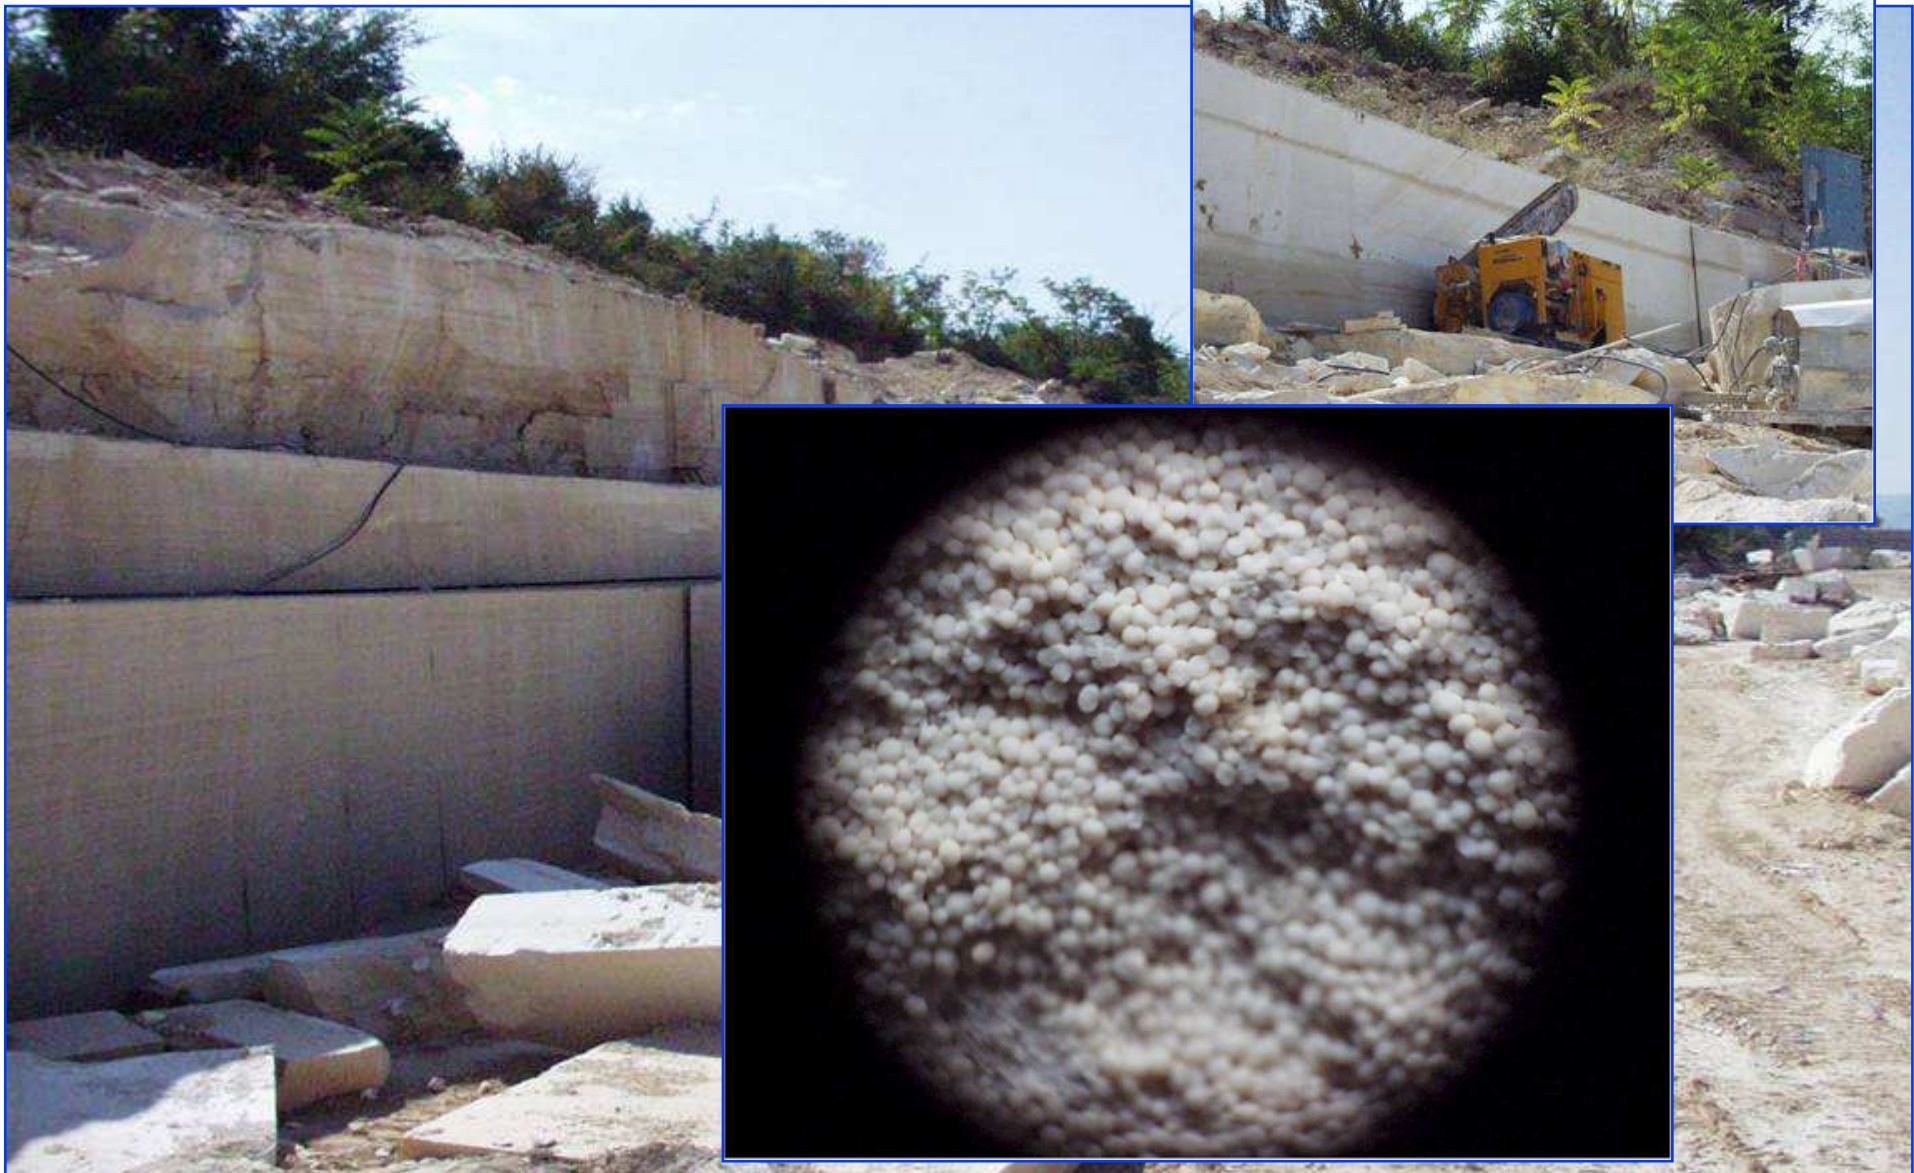
Traces of tools collected for rebuilding cutting chisels – stone surface

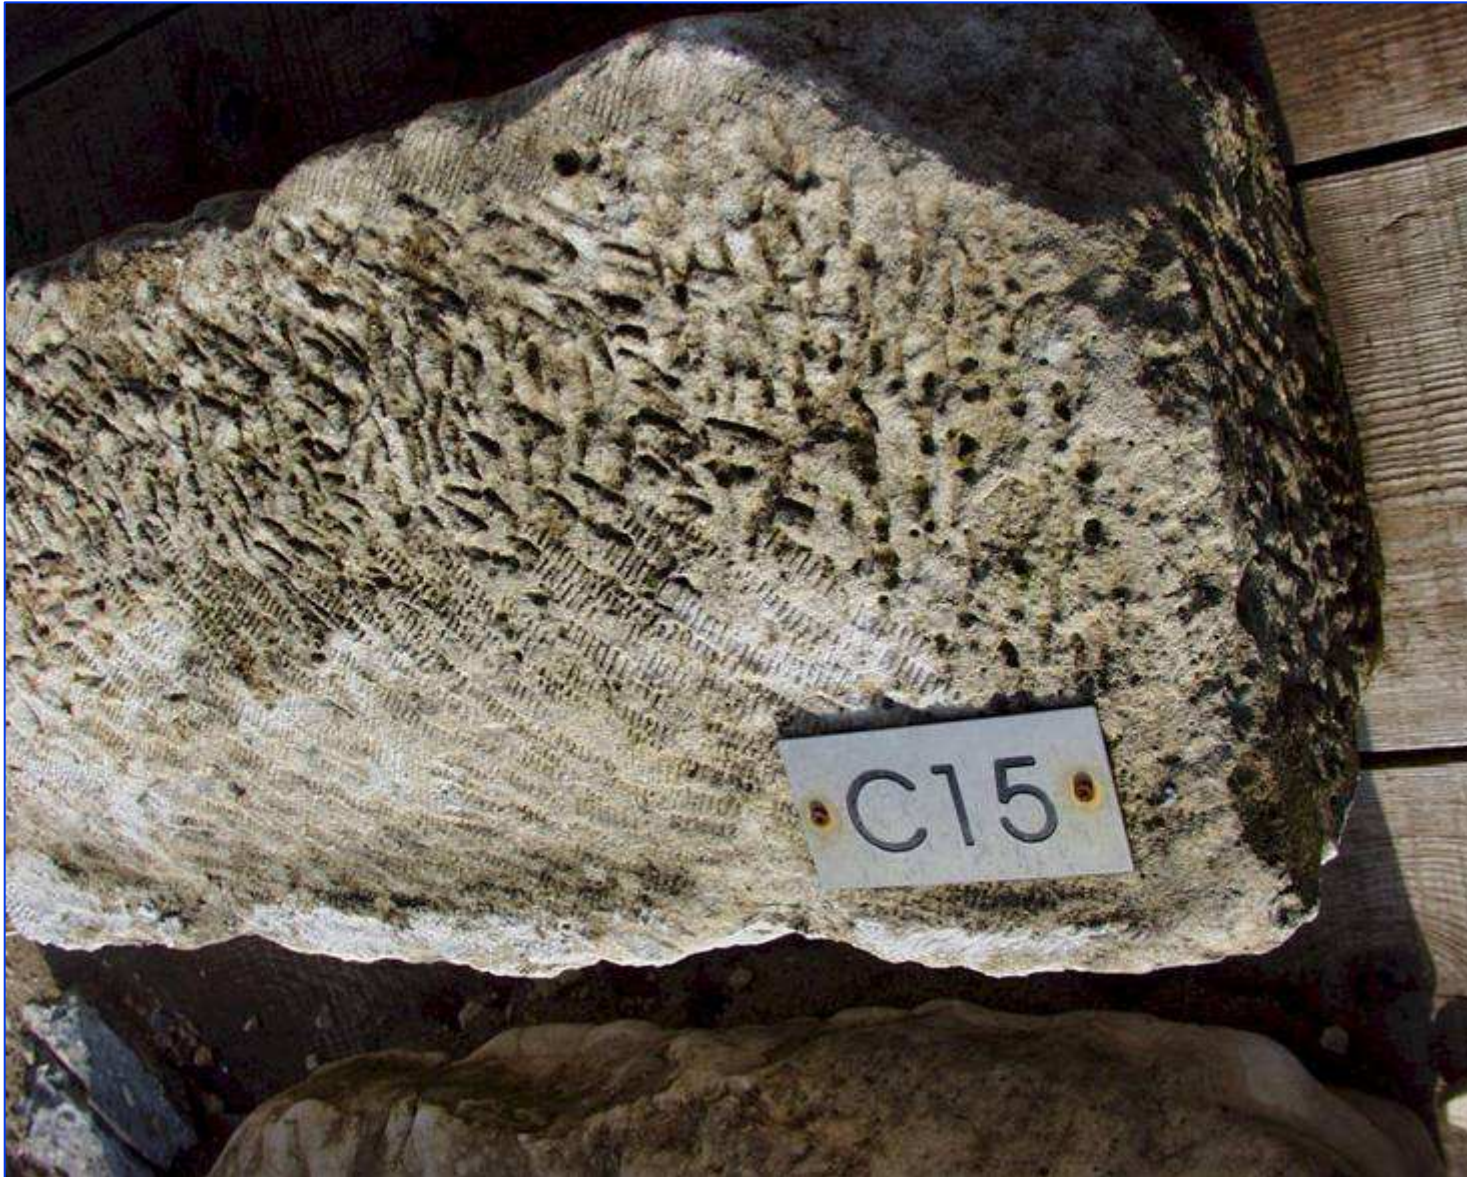
Impact Echo – method to examine all remained original stones

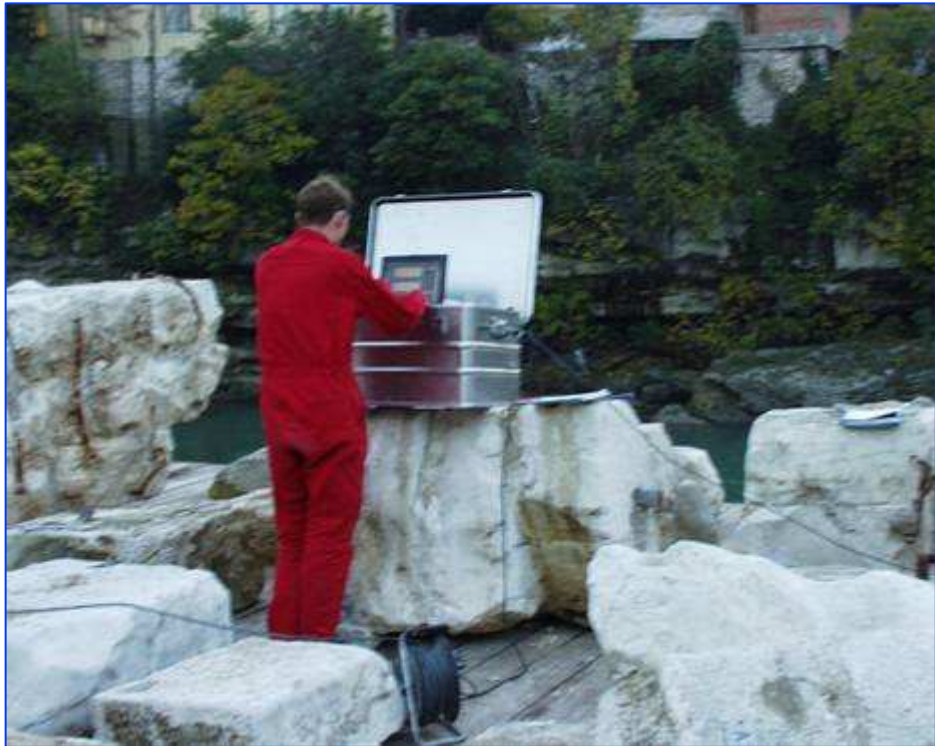
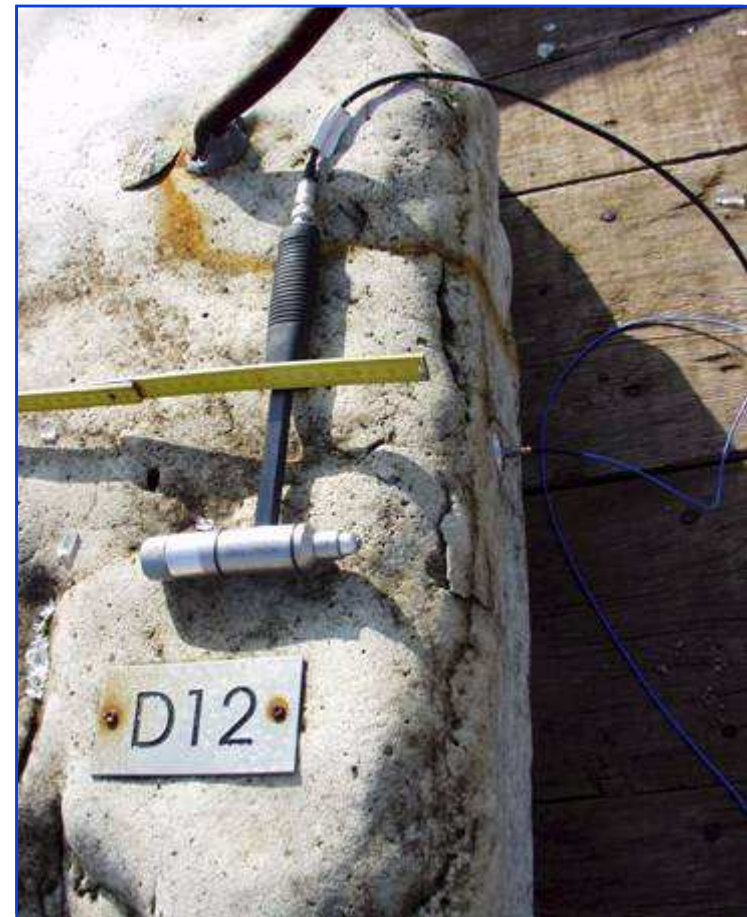
Scaffoldings on ruins for engineering research and sampling

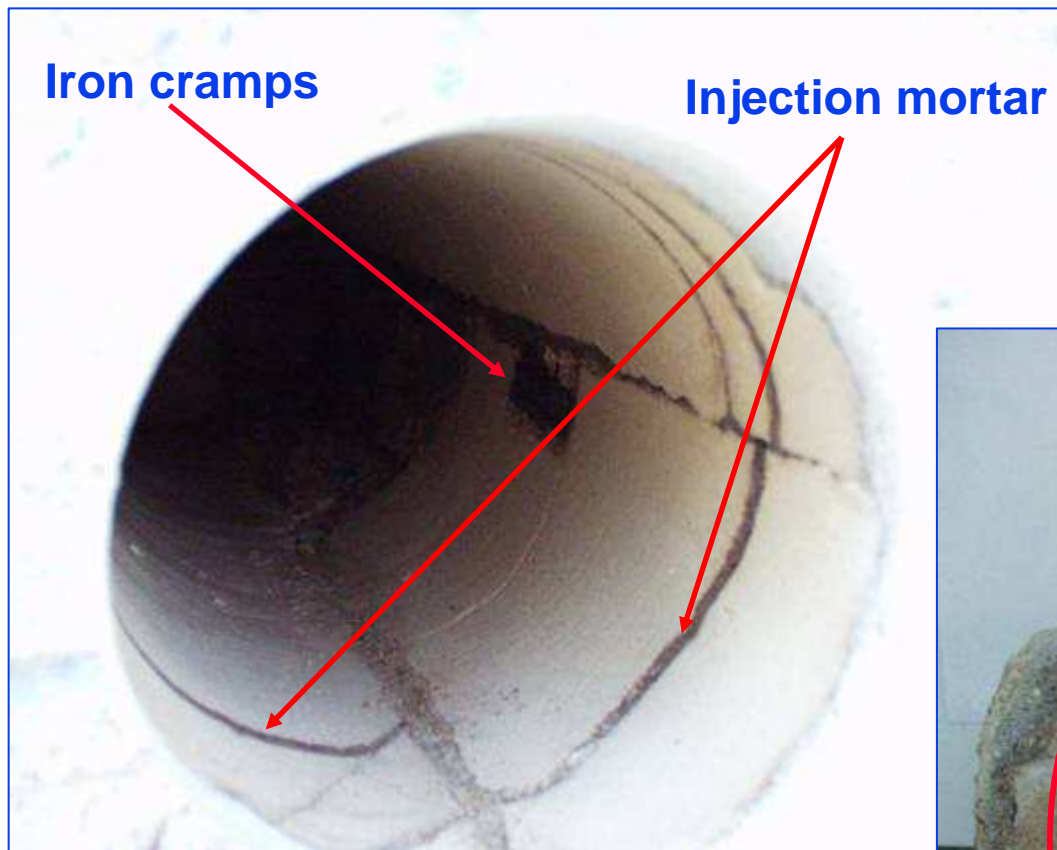
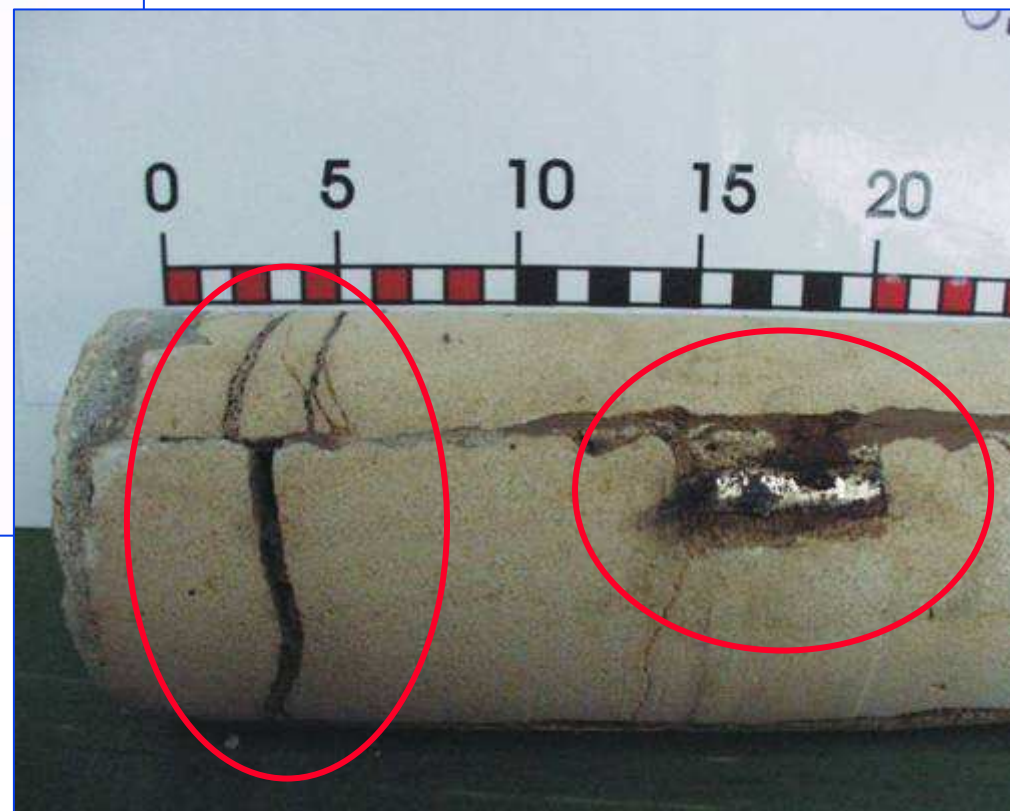
Stone samples: modern yugoslav restoration of old surfaces

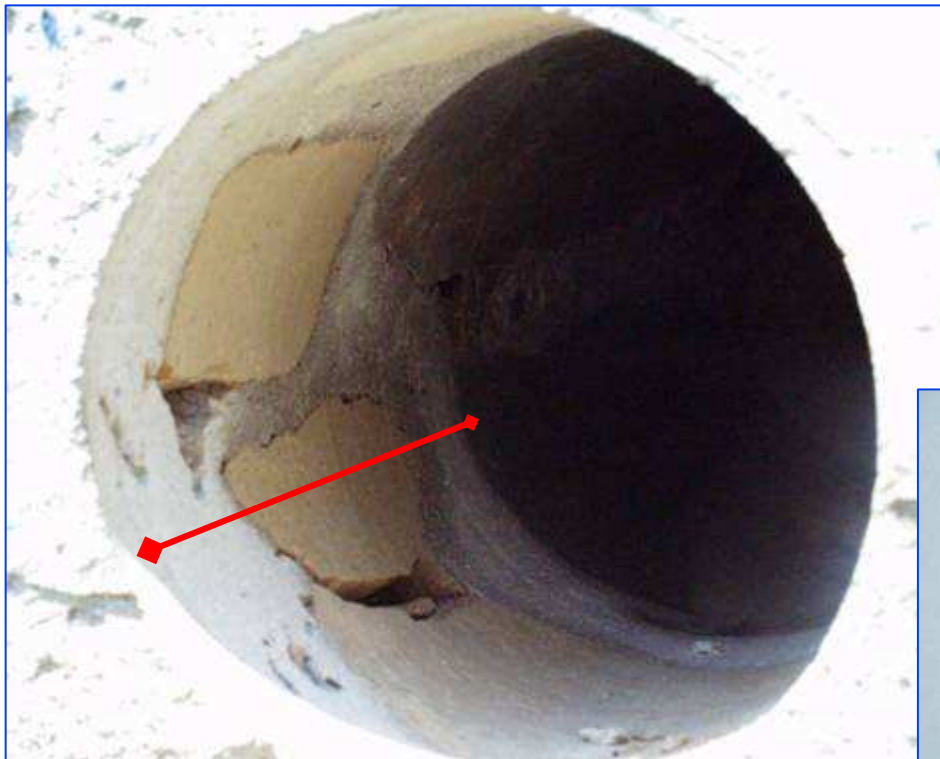
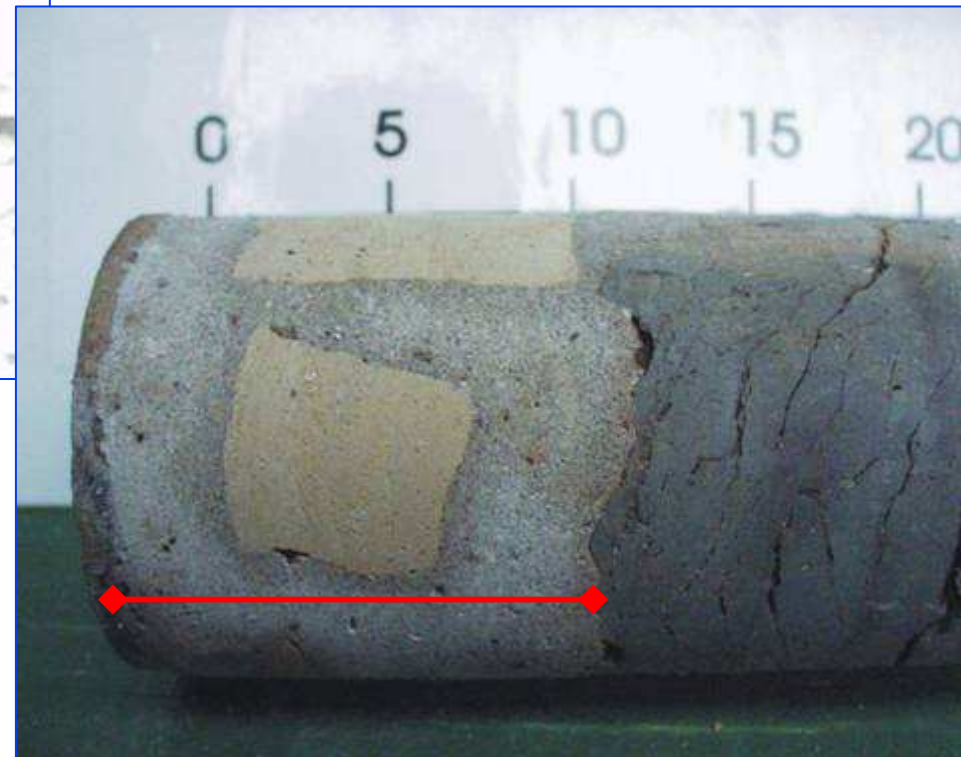
Remained iron dowels in the abutment ruins, connecting ashlar

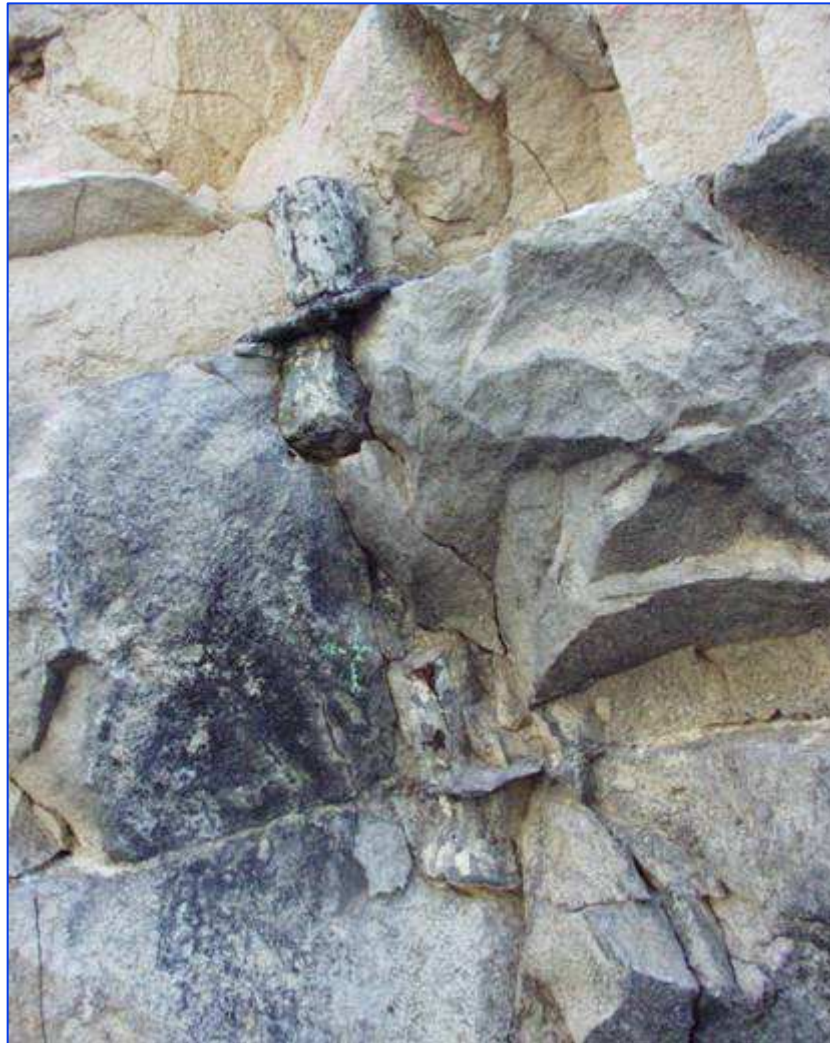
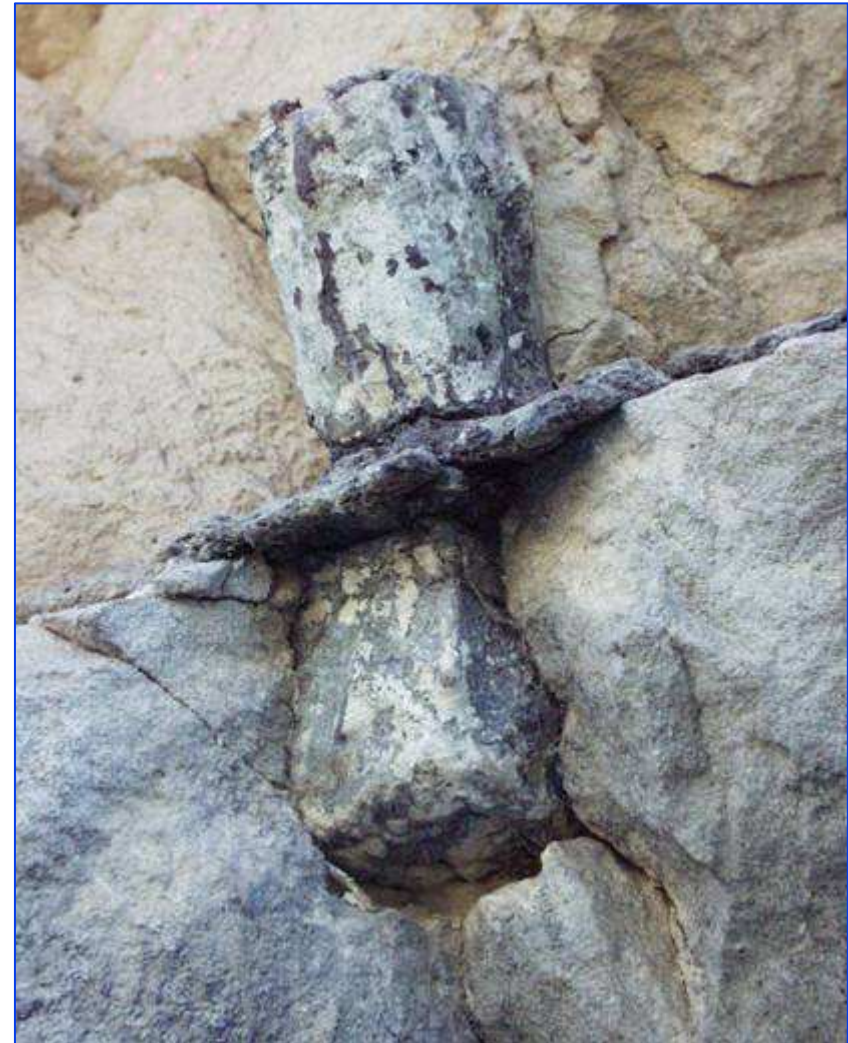
Metallographic detail study – properties, geometry, rebuilding

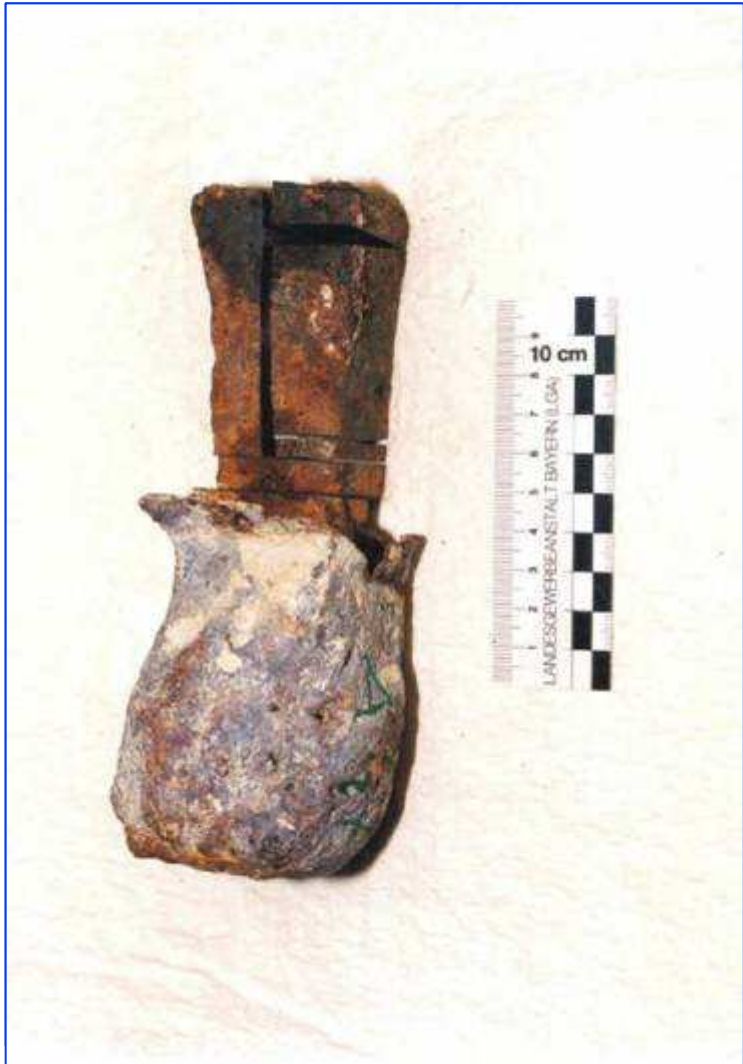
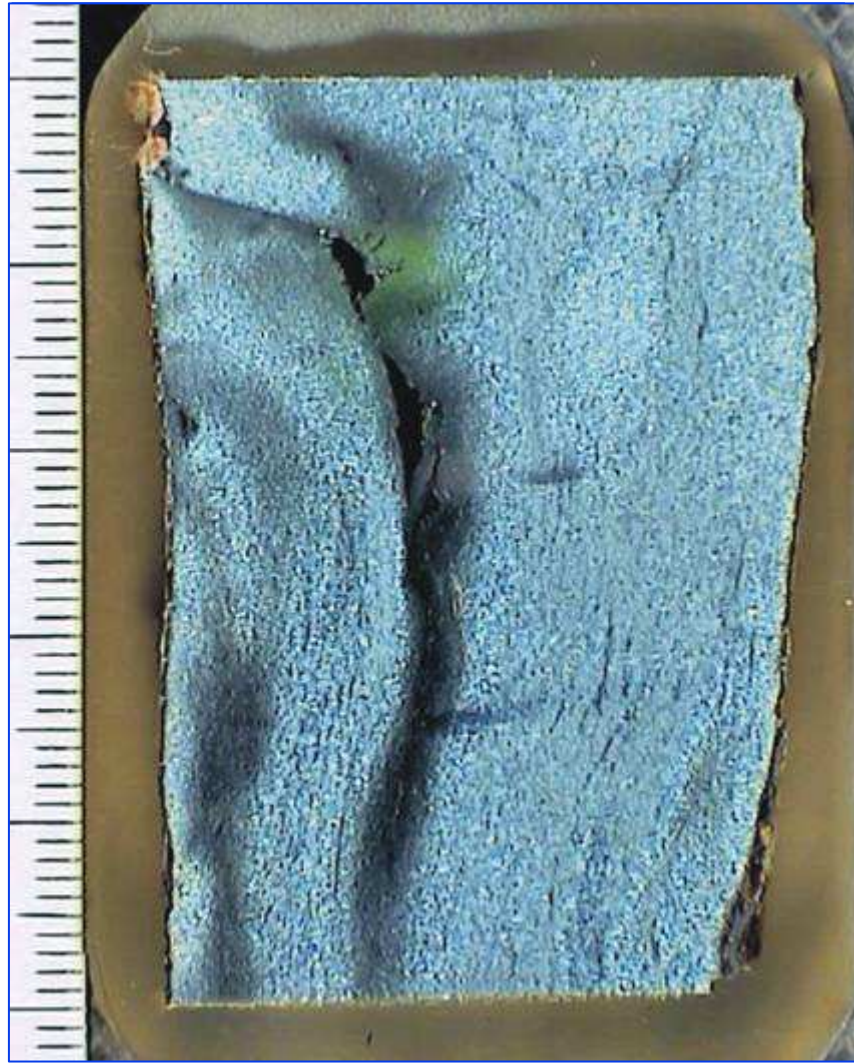
Metal cramps recovered and tested

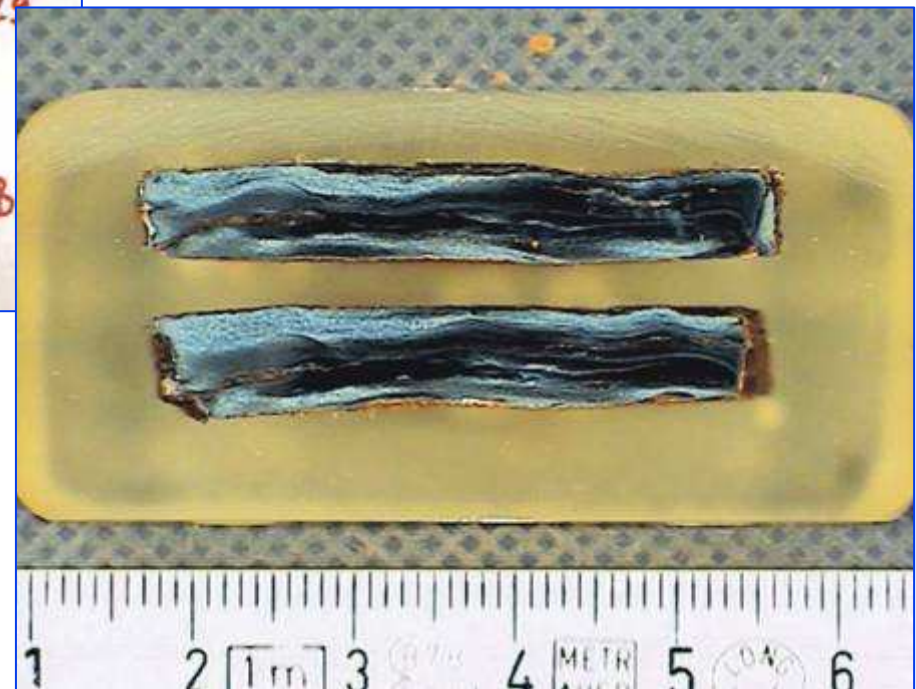
Historic mortar of unique characteristics

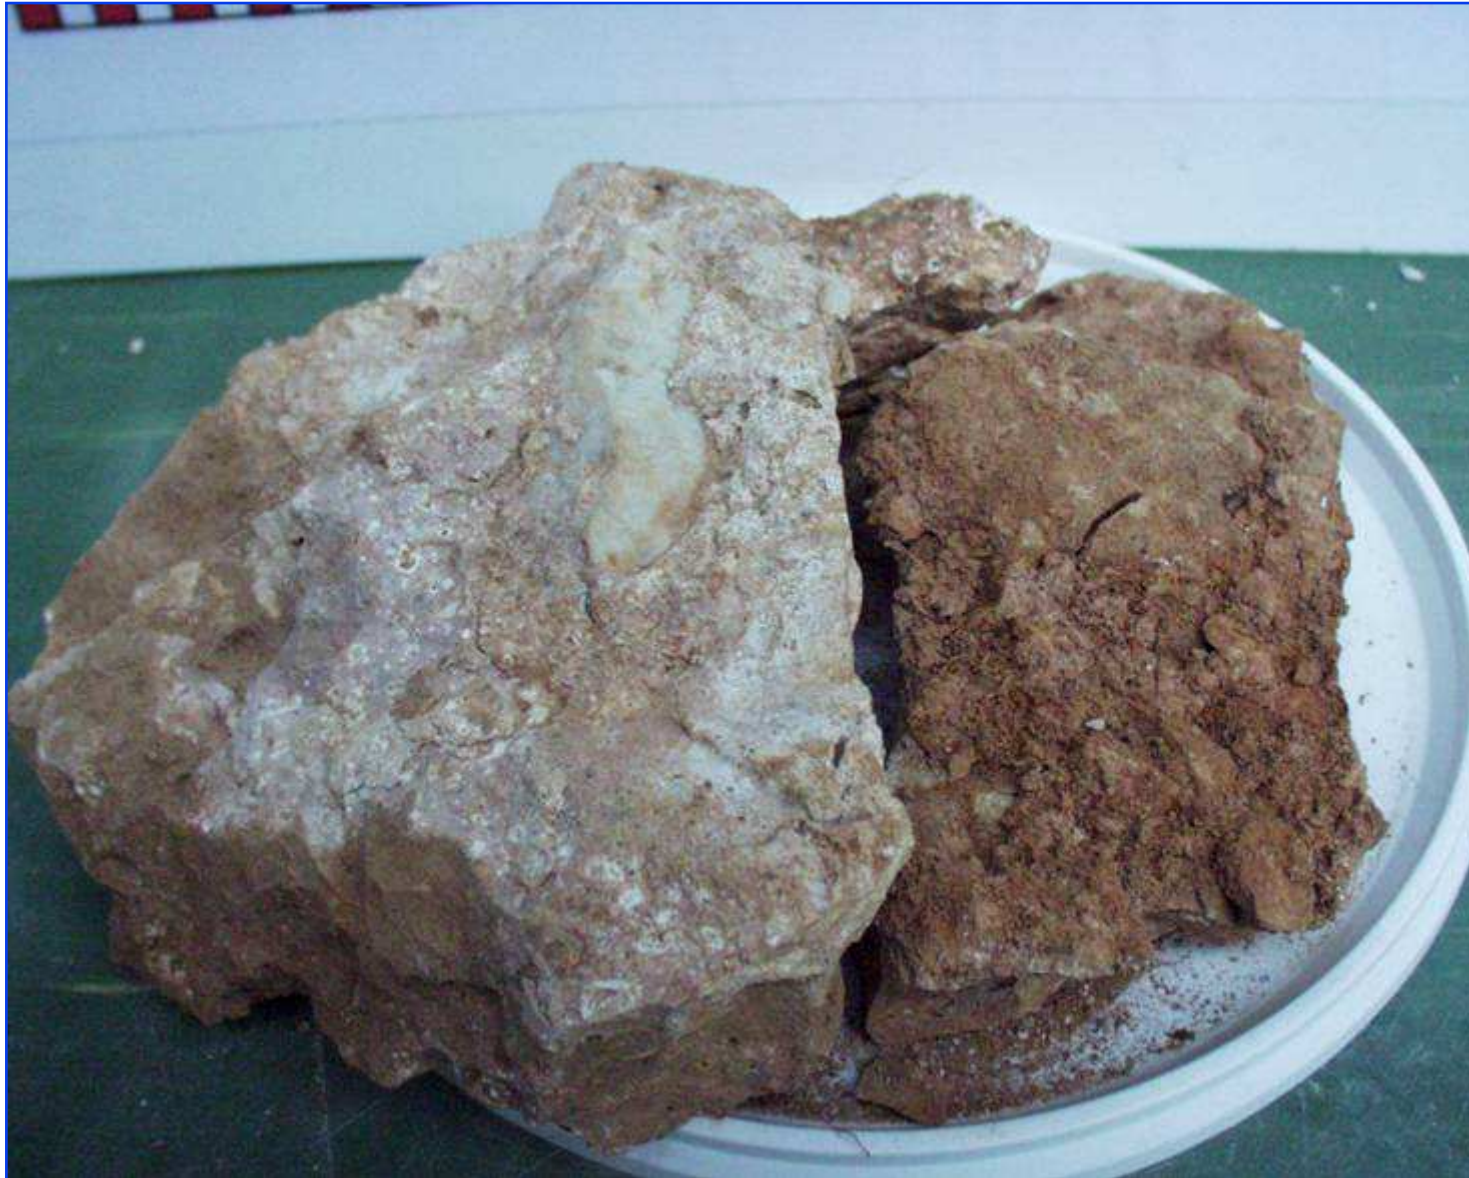
Hydraulic ottoman mortar – analysis and reconstruction

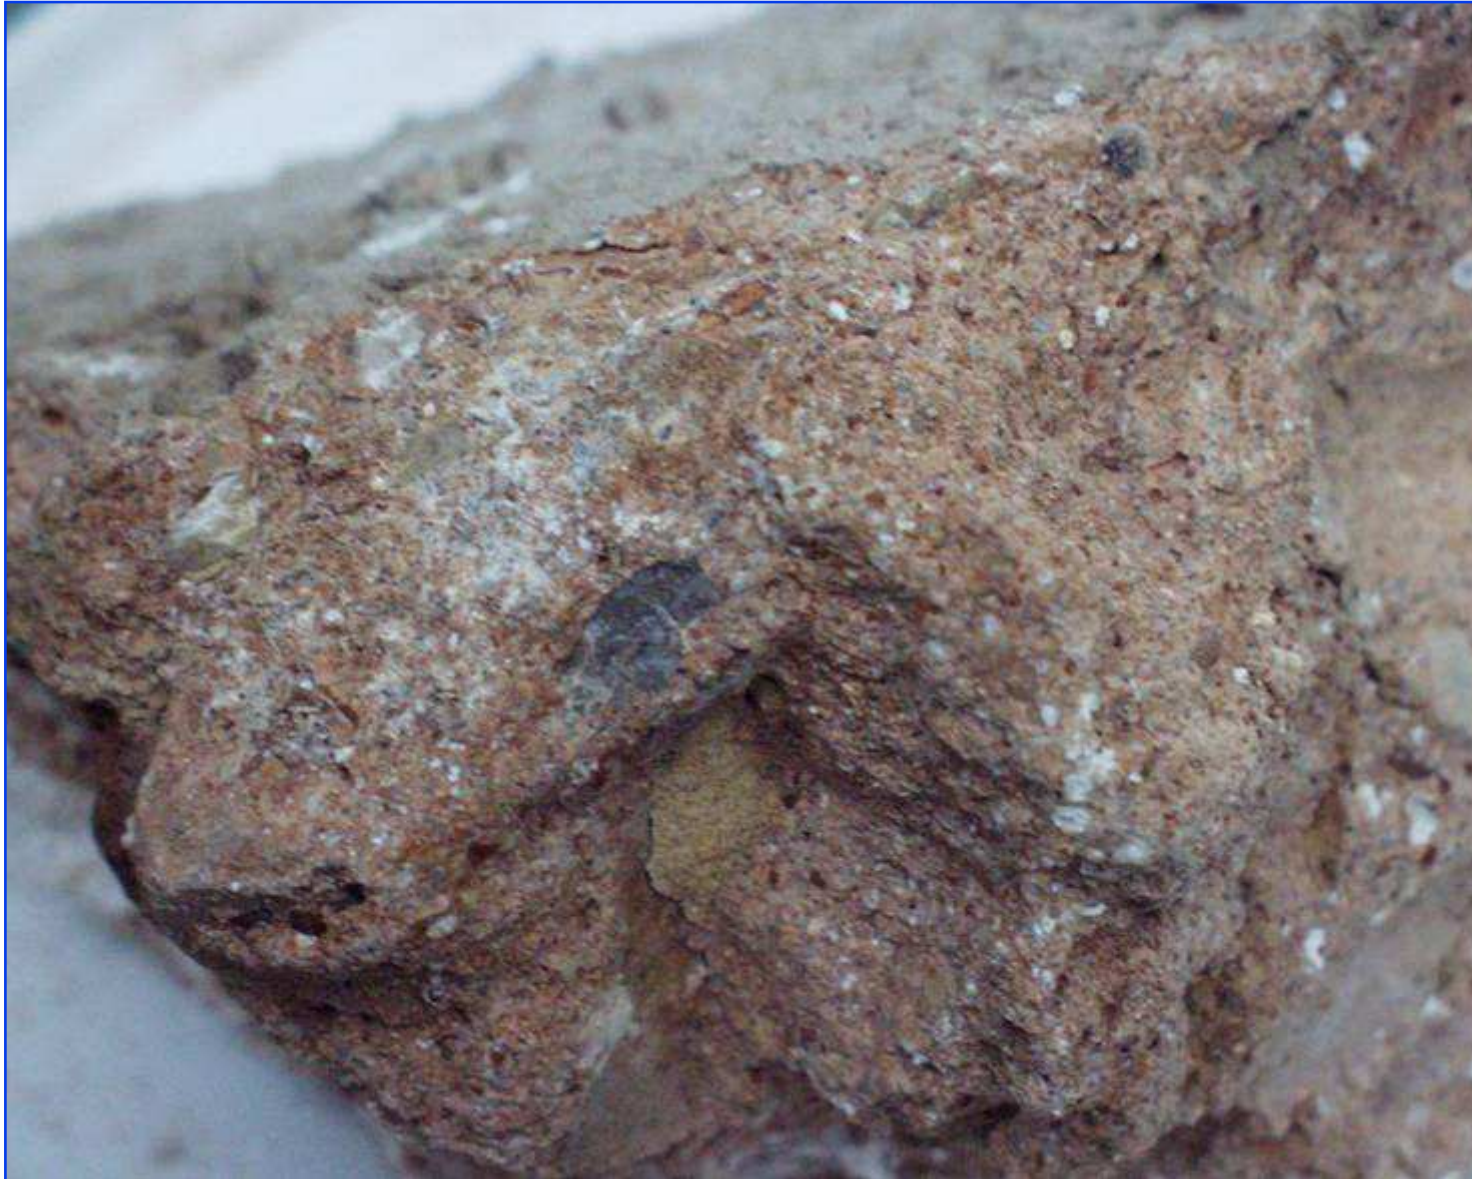
Special soil mixes for the pavement subbase - reconstructed

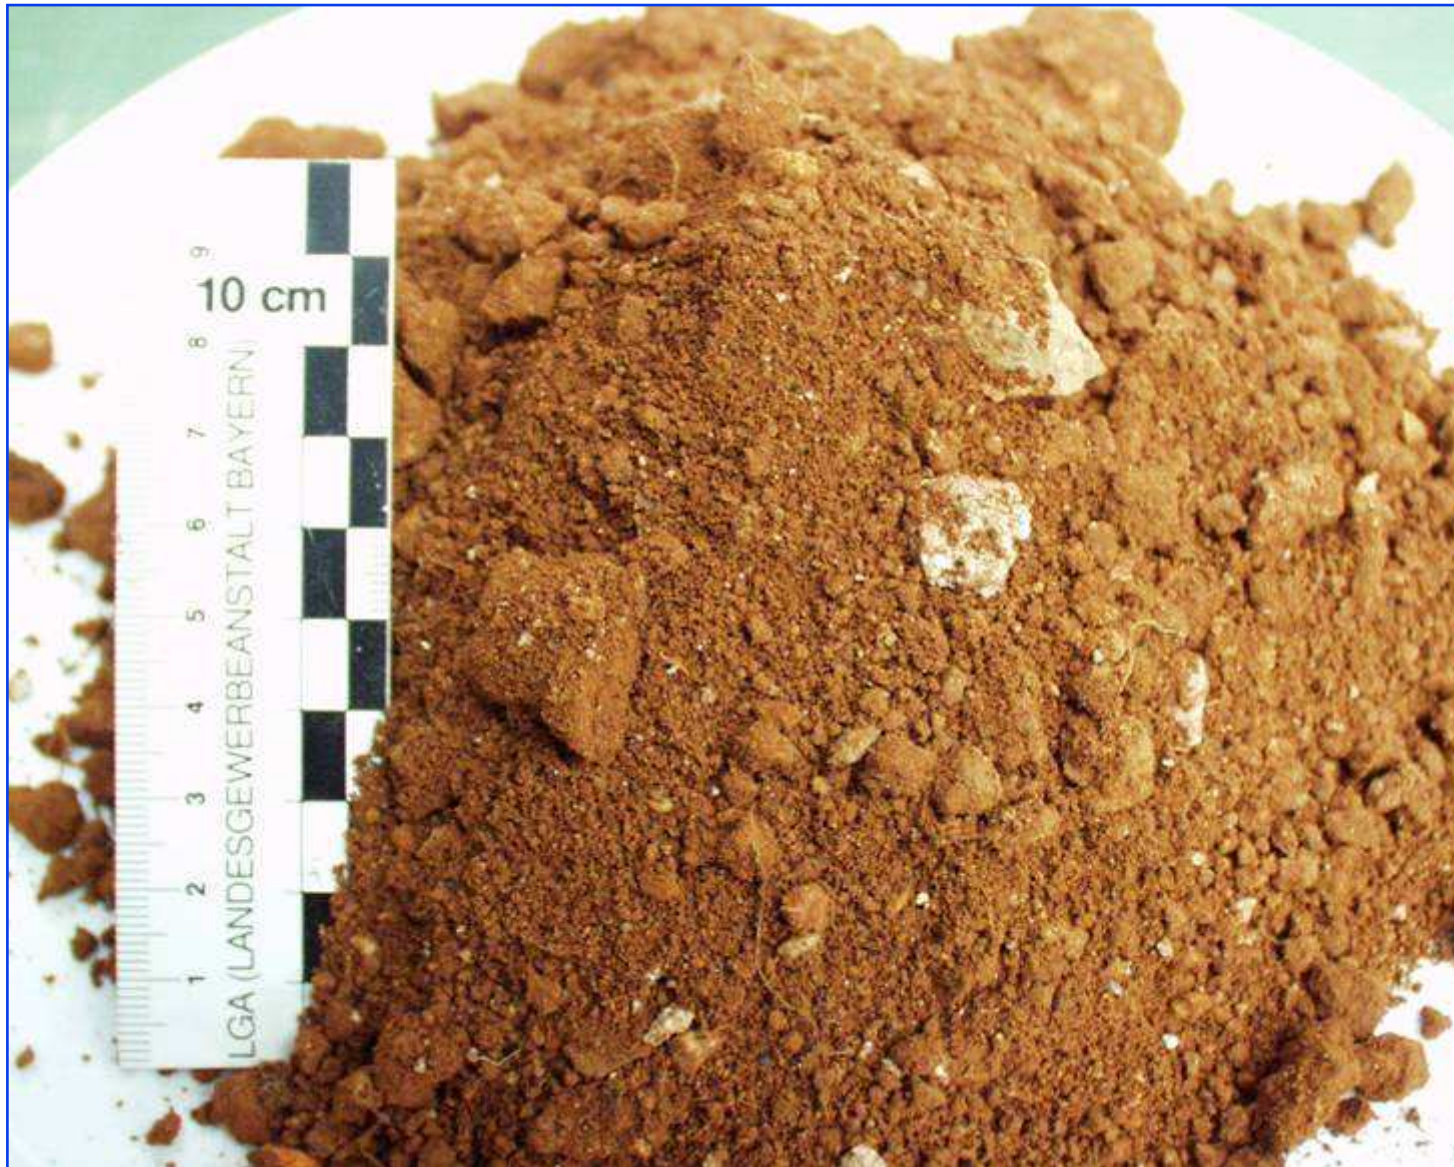
Mortar research and preparation of new mortars

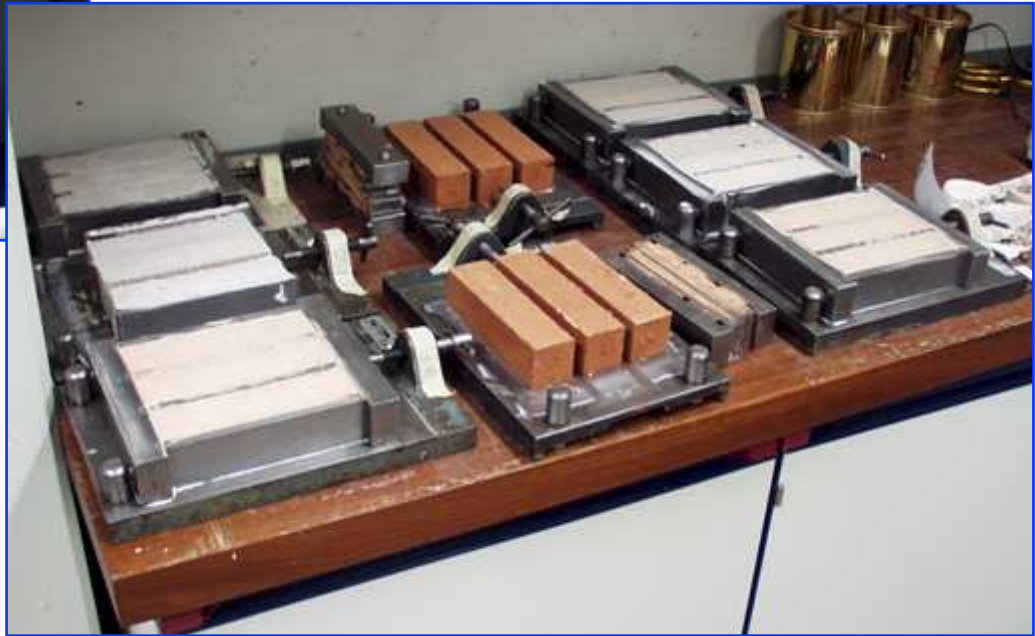
Rebuilding the bridge in 1:4 scale with iron dowels and cramps
