Dipl.-Ing. Gregor Stolarski, Germany

Design baseline for reconstruction – archives deliver old materials

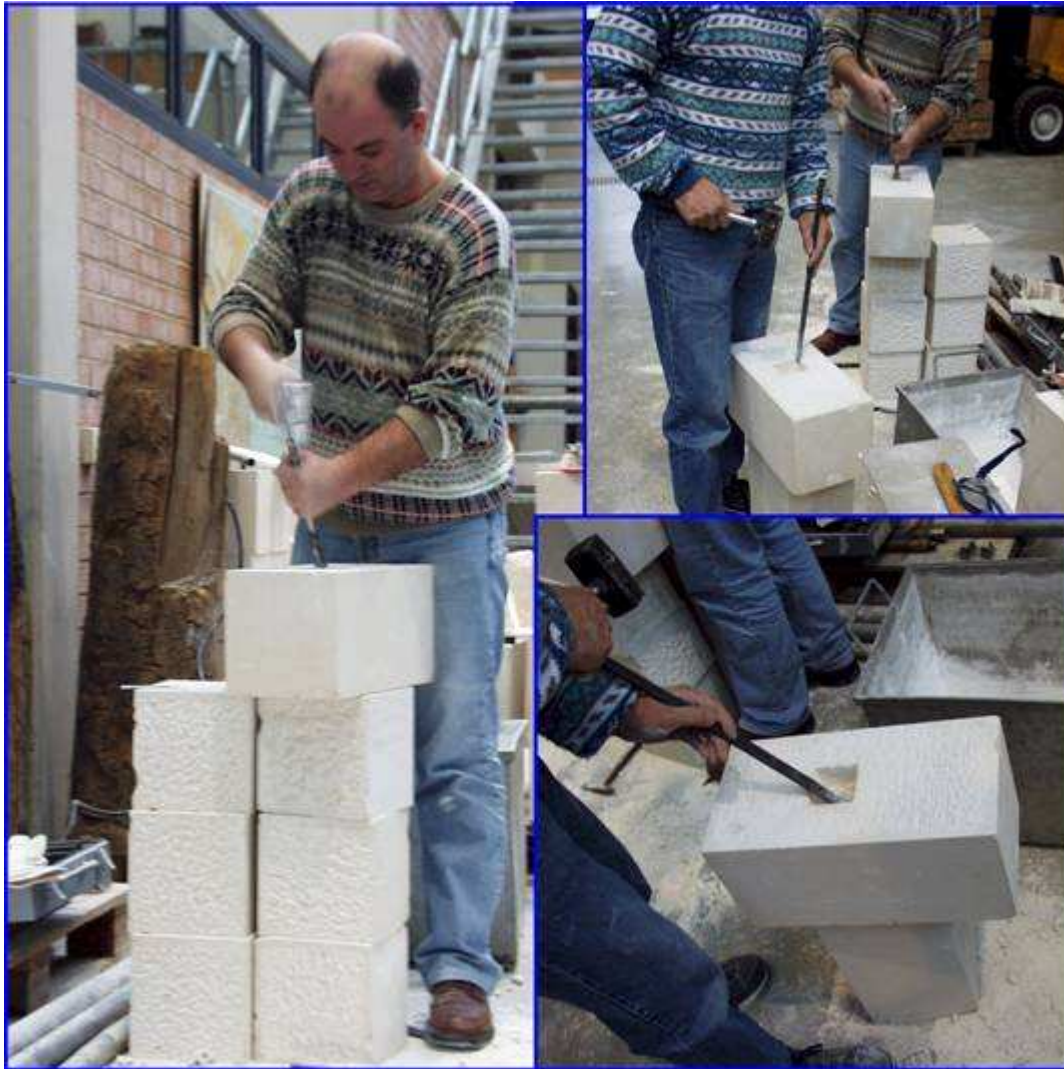
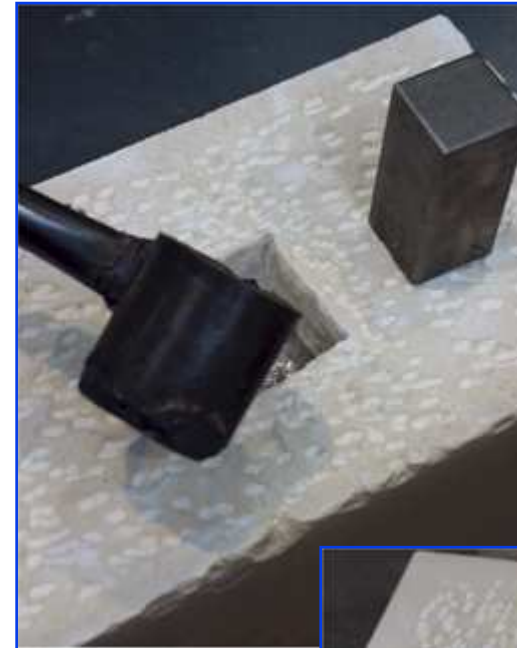
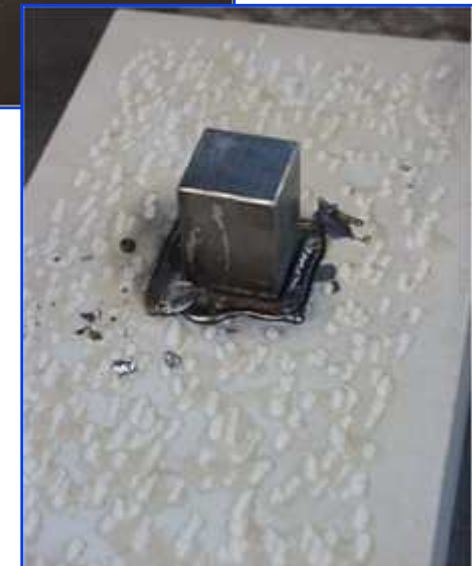
Pouring channels for liquid lead inside stones – technology tests

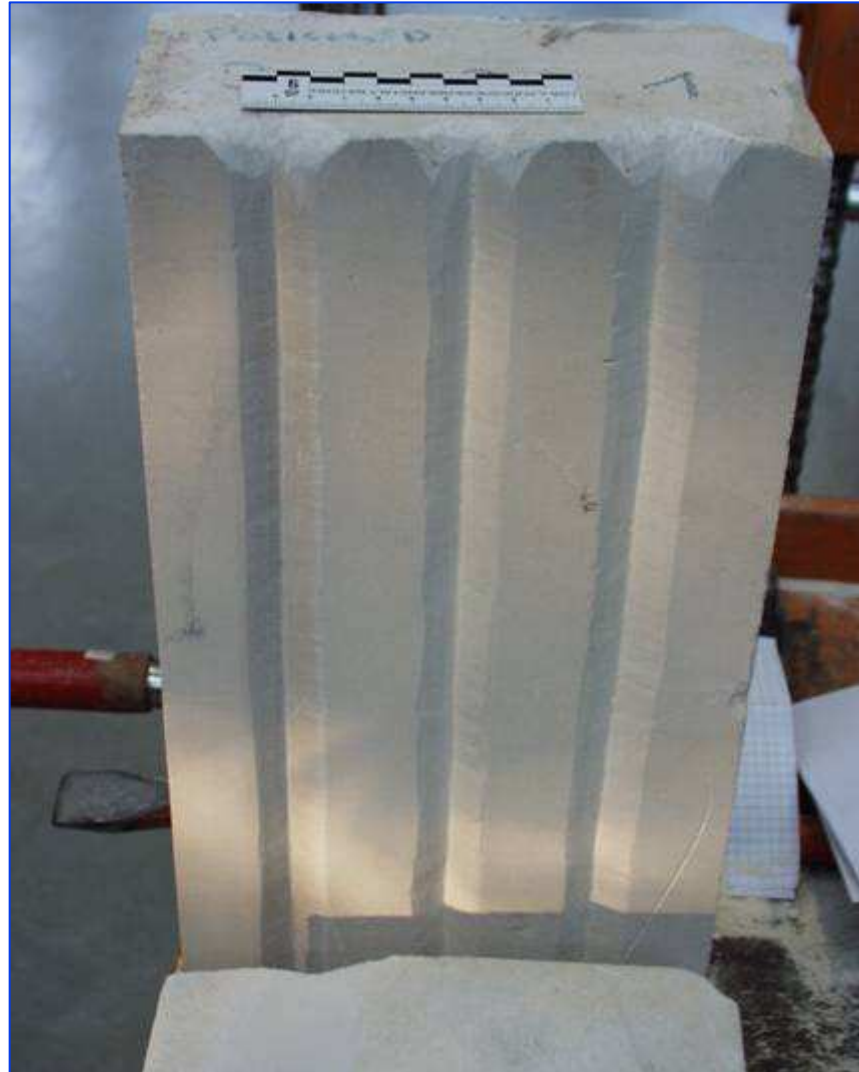
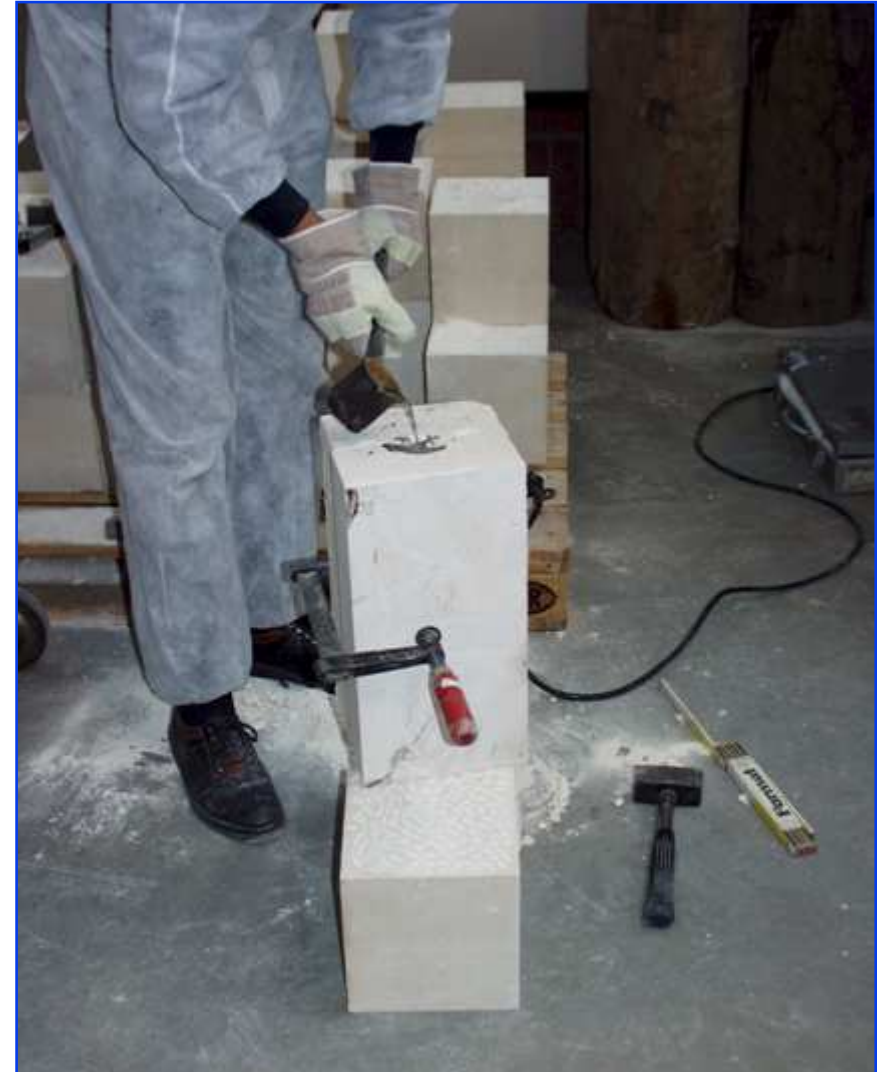
Bearing tests on models to scale stone masonry with metal components
